The Effects of Ultrasonic Cleaning on Device Degradation — Quartz Crystal Devices

B. P. Richards, P. Burton and P. K. Footner

GEC-Marconi Ltd, Hirst Research Centre, Wembley, England

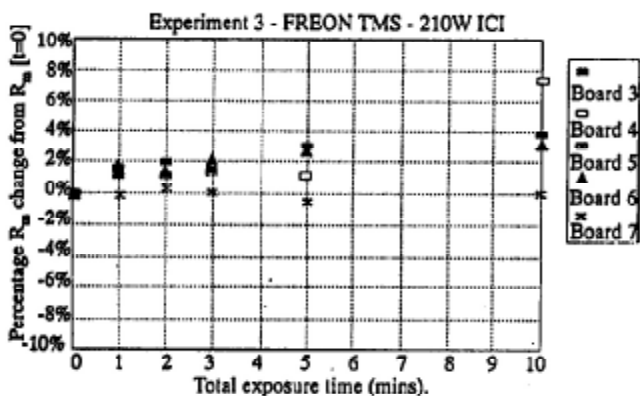
Fig. 2 Variation of R_m as a function of exposure time for low power density exposure for resonator A.

The results are summarised in Table 3 and the variation of R_m as functions of exposure time in CFC are presented in Figures 2 and 3. The salient features are as follows:

- Using low power density exposure, only one failure was encountered. The device failed completely fairly quickly and is regarded as an 'infant mortality' (i.e., failure due to manufacturing defects). A second device exhibited an R_m change > 10% after 10 minutes.

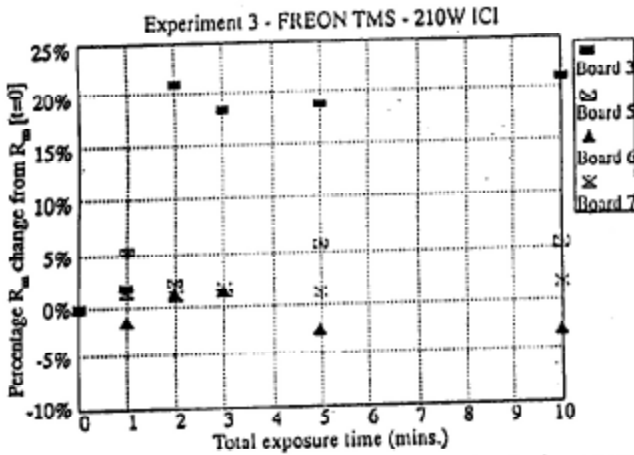
Fig. 4 Variation of R_m as a function of exposure time for low power density exposure for resonator B.

The results are summarised in Table 4 and the variations of R_m as functions of exposure time are presented in Figures 4 and 5. The salient features are as follows:

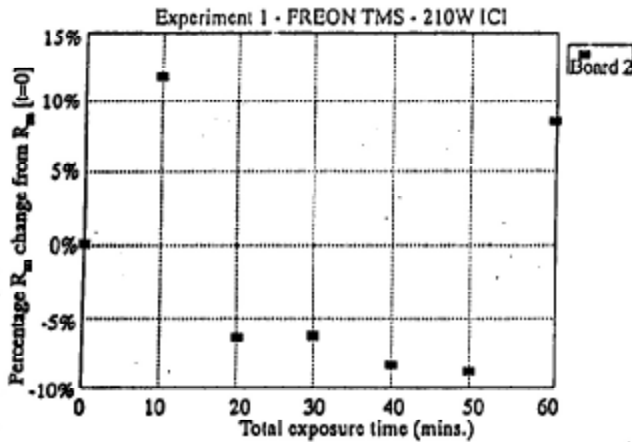
Fig. 7 Variation of R_m as a function of exposure time for low power density exposure for resonator C.

These results are summarised in Table 5 and Figures 7 and 8. The main points were as follows:
